Southeast Region
Big Cypress National Preserve
Monroe Station
50910 Tamiami Trail East
Ochopee, FL, 33943

OVERVIEW

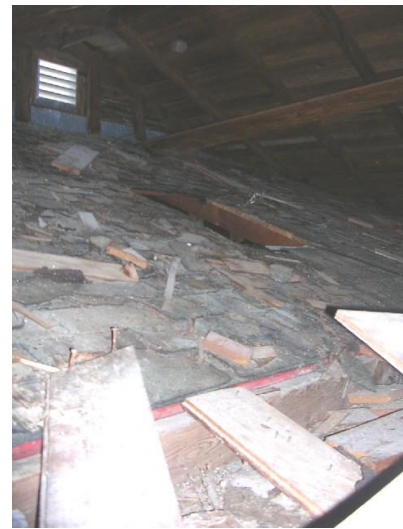
The roof structure visible from the exterior is a gabled roof added to the south face of the original hipped roof. Three faces of the original structure are still visible from the exterior while the fourth face, including the asphalt shingles, is intact under the modern roof.

The south portion of the original roof is extant beneath the gabled roof structure

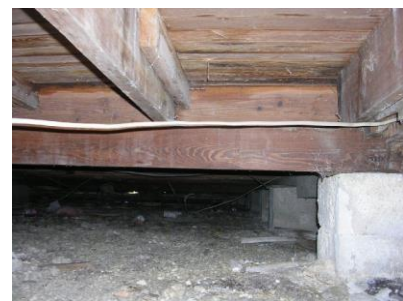
3. **Foundation**—The entire structure is built on concrete blocks which are on a concrete pad. A concrete curb/flower bed encloses the north elevation. Debris or a concrete curb around the perimeter prevents access to the majority of the foundation. A few photos were taken through holes in the flooring and from those vantage points the floor system appears to be in good shape.

View of the foundation system taken from the hole in the floor in the middle of the front room of the Central Core.

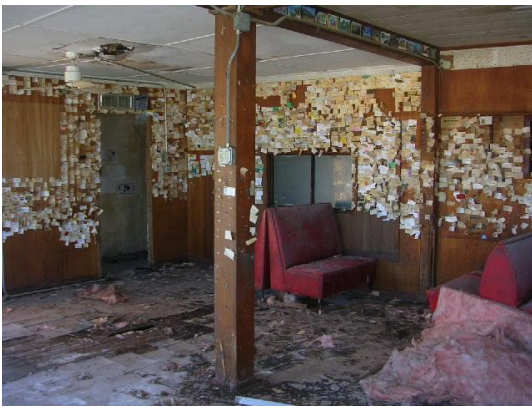
View from within the footprint of the Original Structure looking west toward the initial shed addition. The post in the center of the photo indicates the southeast corner of the Original Structure. Note business cards on the walls.

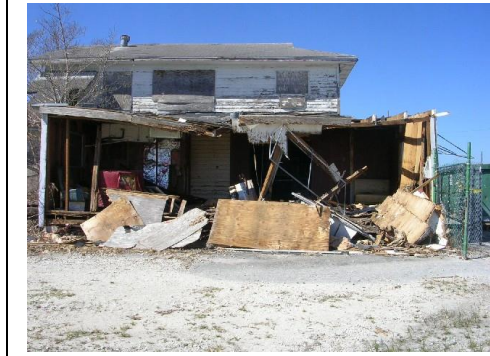
The east shed addition received the most damage during the hurricane.

This addition is largely destroyed both from hurricane and termite damage. Plywood has been torn from the studs, unprotected windows and door openings expose the interior to the elements. The joists, sills and some of the studs are riddled with termite damage. The plywood flooring is spongy from termite damage.

Like the west addition, the east addition is constructed of dimensional lumber and plywood, and was devastated by the hurricane winds. The entire east wall was ripped off as was most of the roof for this room.

1. Carefully “de-construct” the recent shed additions on the east and west elevations. The west addition can be totally removed up to the Original Structure’s west wall. Use caution when removing the framing elements attached and flashed against the Original Structure.
2. The removal of the east addition will be a little more complex in that it is a continuation of a previous addition which needs to remain. The recent east elevation floor structure can be removed/de-constructed up to the exterior wall of the initial addition, which includes a slight bump-out hallway along

the east elevation. The shed roof of this recent addition, however, needs to be de-constructed carefully to provide a minimum 1' overhang remaining to the initial addition. Salvage any shiplap siding from the additions to be removed for replacement of missing siding.

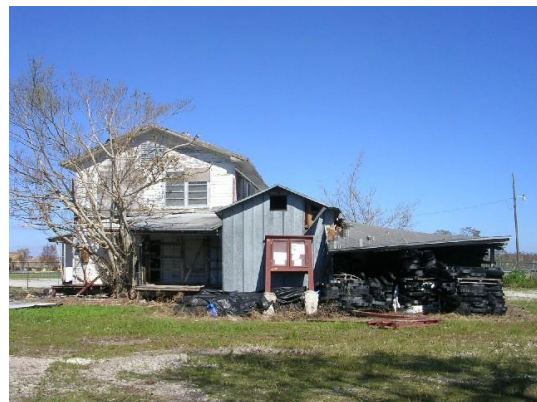
The east shed which is currently housing trail material, suffered some wind damage, resulting in the southwest corner of the shed collapsing. It fell approximately 2’ and is supported by the trail material. The central gabled structure is clad in 5-V crimp sheet metal and is in fair condition except for a roof vent that is letting in water. The west structure is topped with a shed roof, is open on the south side, butts against the gable shed on the east and is enclosed with galvanized wire fencing on the north and west.

The south view of the Monroe Station shows the multiple sheds that compose this utilitarian portion of the structure.

In general these structures are in fair condition and are in no danger of damaging the Central Core.

1. Leave the rear additions in place for documentation and analysis during a Historic Structures Report.
2. Shore up the south west corner of the east shed. Remove trail material and store outside the Monroe Station to allow for access to the structure for documentation.
3. Patch the hole in the gabled shed to prevent further water damage.
